Unit Cracking/Gapping - Corners/Bends

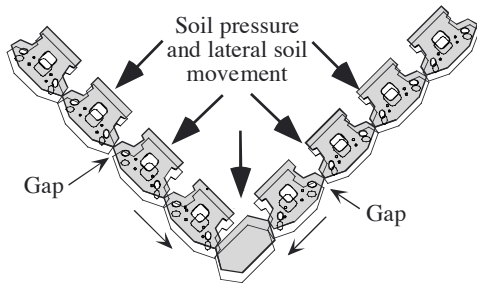
Wall Corner

Keystone modular retaining wall structures can tolerate a certain amount of movement due to the flexible nature of the system and small individual unit size. When corners and tight curves are inserted into an otherwise two dimensional system, a third direction of movement can occur which can cause unit cracking or gapping.

Gapping and cracking noted in these situations usually occurs in taller walls with lesser quality backfill and/or poor compaction. The wall backfill strains and deforms laterally under increasing earth fill load resulting in outward facing movement in the bottom third of the wall height. This is typically not a noticeable problem in straight walls but at corner or bends the movement is magnified and can create the gapping and cracking noted due to the buildup of radial tensile forces along the wall face.

Solution: Use high quality granular fill in tight radius or bend areas in taller walls. Backfill entire zone with 3/4" stone to minimize lateral wall movement.
