▶ CASE STUDY: COMMERCIAL APPLICATION

Keystone Meets 2000 Olympic Standards for Australia Stadium!

- ▶ **PROJECT:** Olympic Stadium
- LOCATION:** Homebush Bay, Australia
- PRODUCT:** Keystone Compac Unit
- SQUARE FOOTAGE:** 80,000 (7420 m²)
- CONTRACTOR:** Multiplex - Construction
- SPECIFIER:** Boral Besser Masonry Retaining Wall Contractor
- KEYSTONE REPRESENTATIVE:** Boral Besser Masonry Sydney, Australia

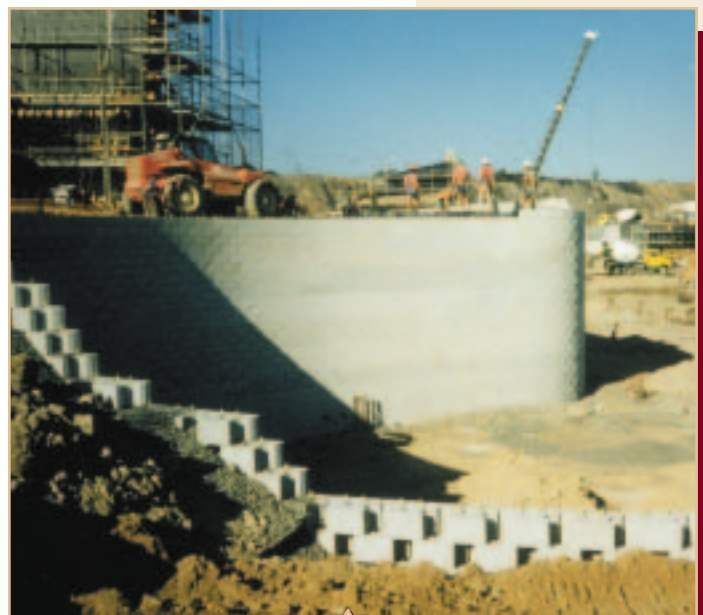
High quality results using smooth texture Keystone units and multiple radii layout.

Many challenges arose from the change in face texture. The smooth face of the block is more susceptible to chipping than a split-face or corduroy texture unit, which meant that 15% of the custom made blocks had to be replaced compared to only 1% of the original block. Due to the complexity of the design, which included radii that ranged from 9m (29.5 ft.) to 180m (590 ft.), 15,000 of the 80,000 blocks used were individually cut to ensure that the many wall curves were perfectly smooth.

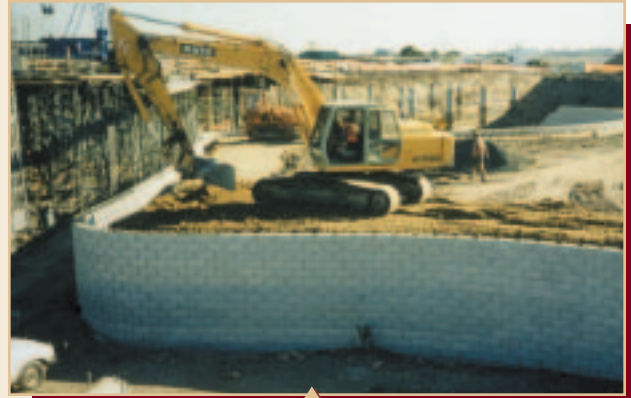
Keystone offers durable structure with flexible design capabilities

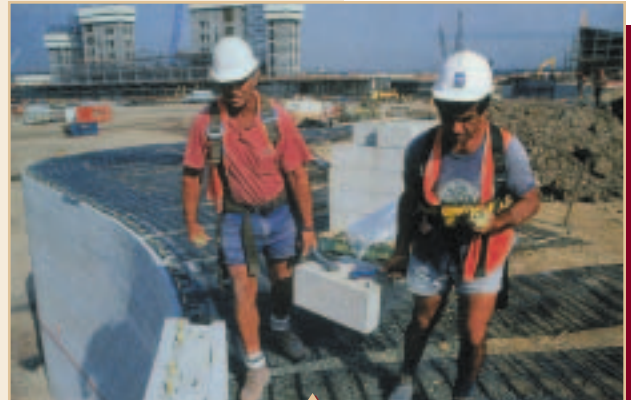
Construction continues with Keystone and geogrid
