▶ CASE STUDY: VENEERING

Keystone Walls With Native Rock Facing; A Beautiful Combination!

- ▶ **PROJECT:** Bachelor's Gulch
- LOCATION:** Avon, Colorado
- PRODUCT:** Keystone Standard Units
- SQUARE FOOTAGE:** 43,000 s.f.
- CONTRACTOR:** B & B Excavation
Edwards, Colorado
- SPECIFIER:** Advanced Wall Structure
Prior Lake, Minnesota
- KEYSTONE REPRESENTATIVE:** Best Block Company
Littleton, Colorado

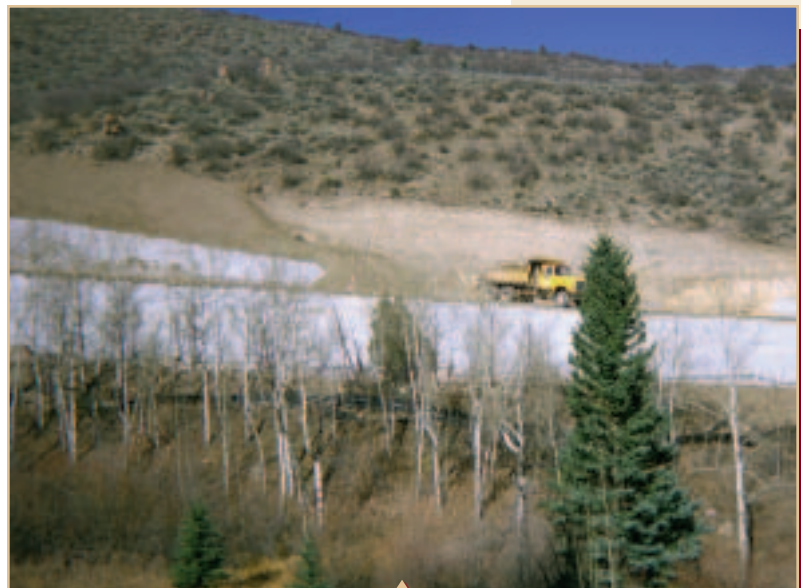
View of completed wall prior to placement of moss stone veneer.

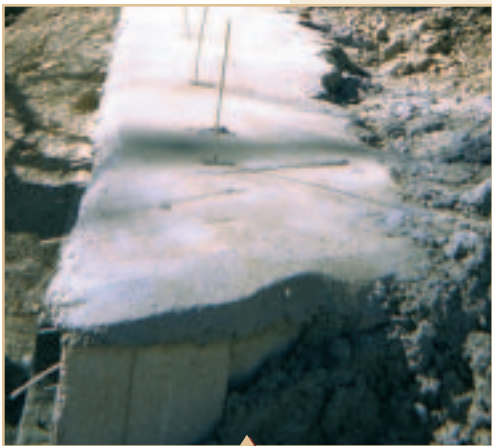
View of top of wall elevation showing grouted cap serving two purposes: (1) seal off water (2) secure wire to units and provide clean surface for rock attachment.

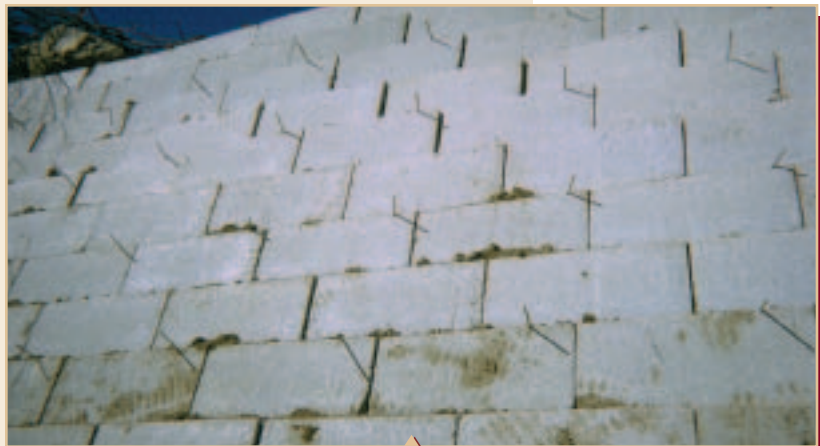
Straight face, unsplit KEYSTONE Standard units with a 9 gauge wire provided the surface and method for attaching the rock veneer.

Modifications for attaching the rock veneer to the Keystone units were relatively simple; but because of time constraints associated with the project and the time required to adjust the mold, the individual Keystone units were modified in the field. As the units were being placed on the wall, the contractor cut a groove large enough to accommodate a 9 gauge wire tie in every unit, every other course.
